# METRO THERMAL ASH MONOFILL CLOSURE CAP

## STORMWATER DAMAGE AND RESTORATION UPDATE

# METRO THERMAL ASH MONOFILL

## Metro Nashville Public Works

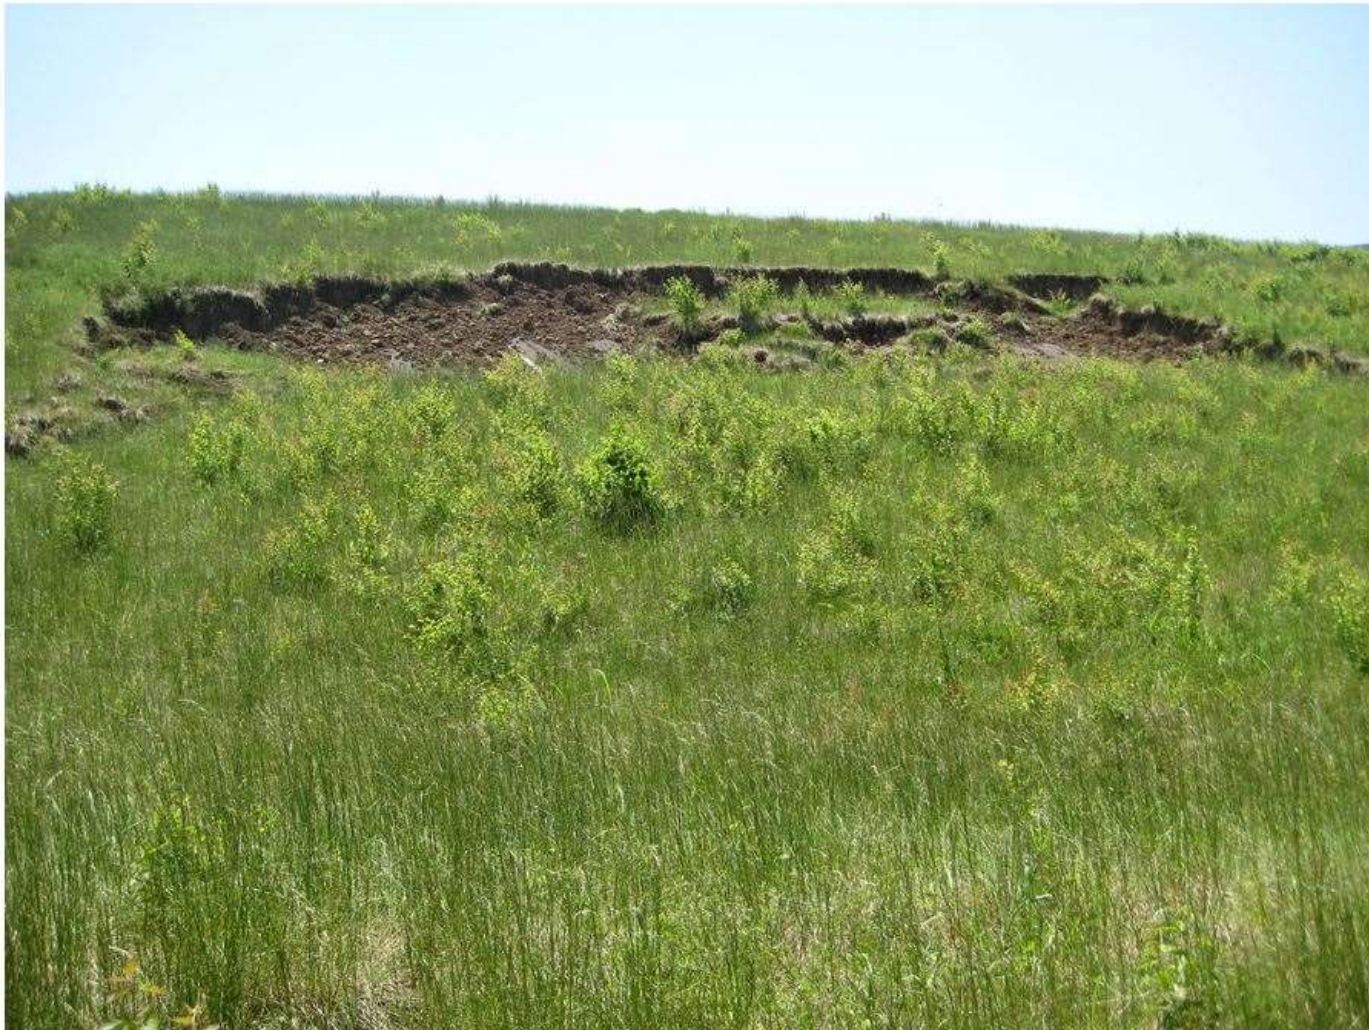
**Photo 2. (North Slope) Scarp Immediately Down Slope from Bench**

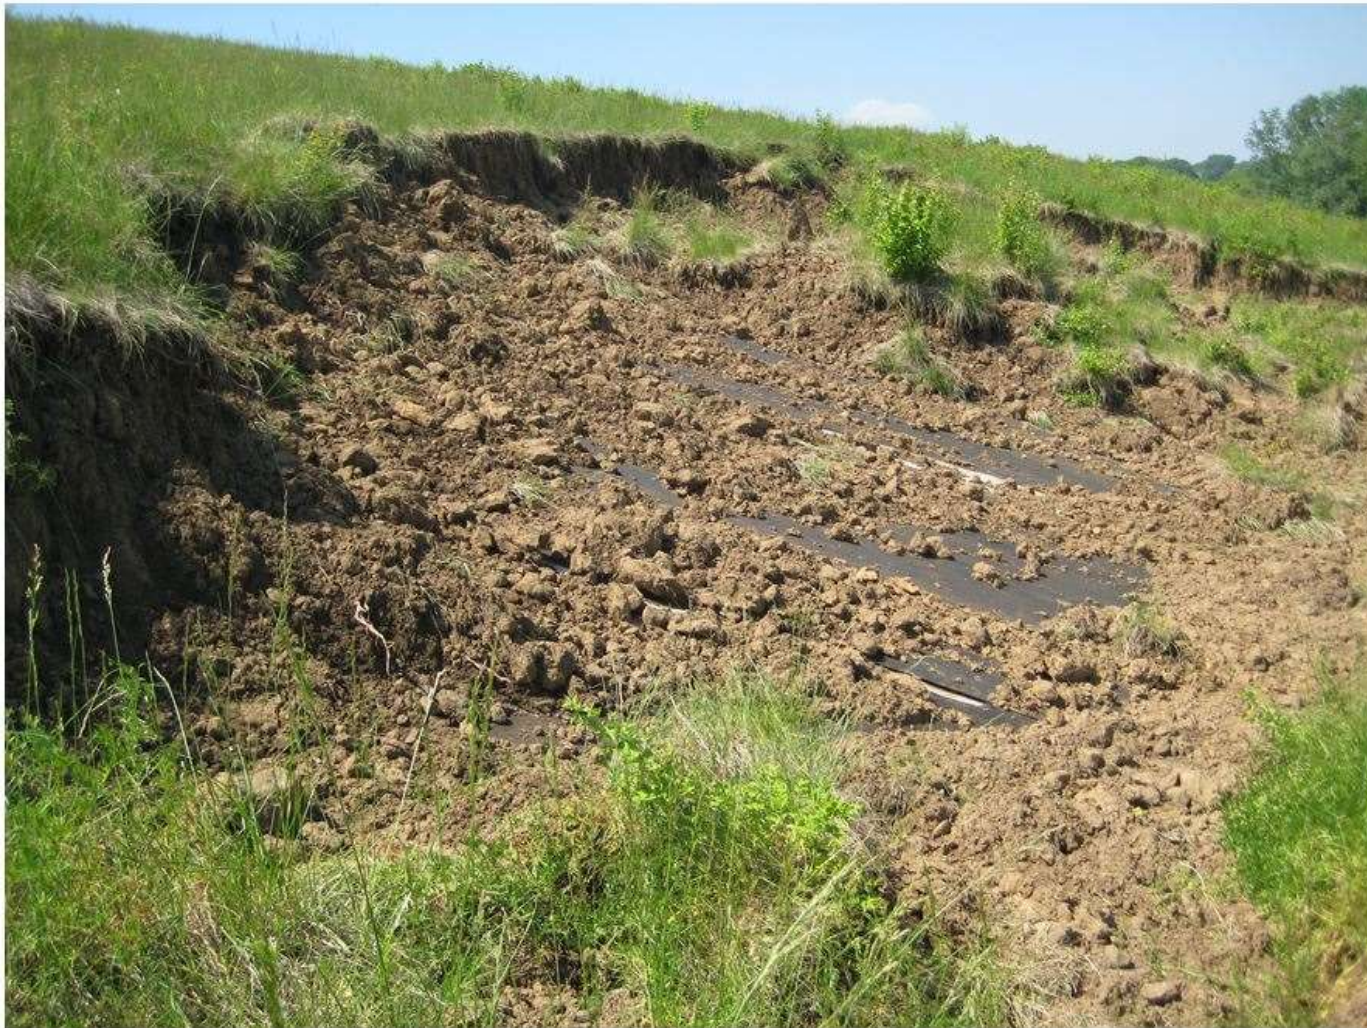
**Photo 3. (North Slope) Scarp and Exposed Geocomposite**

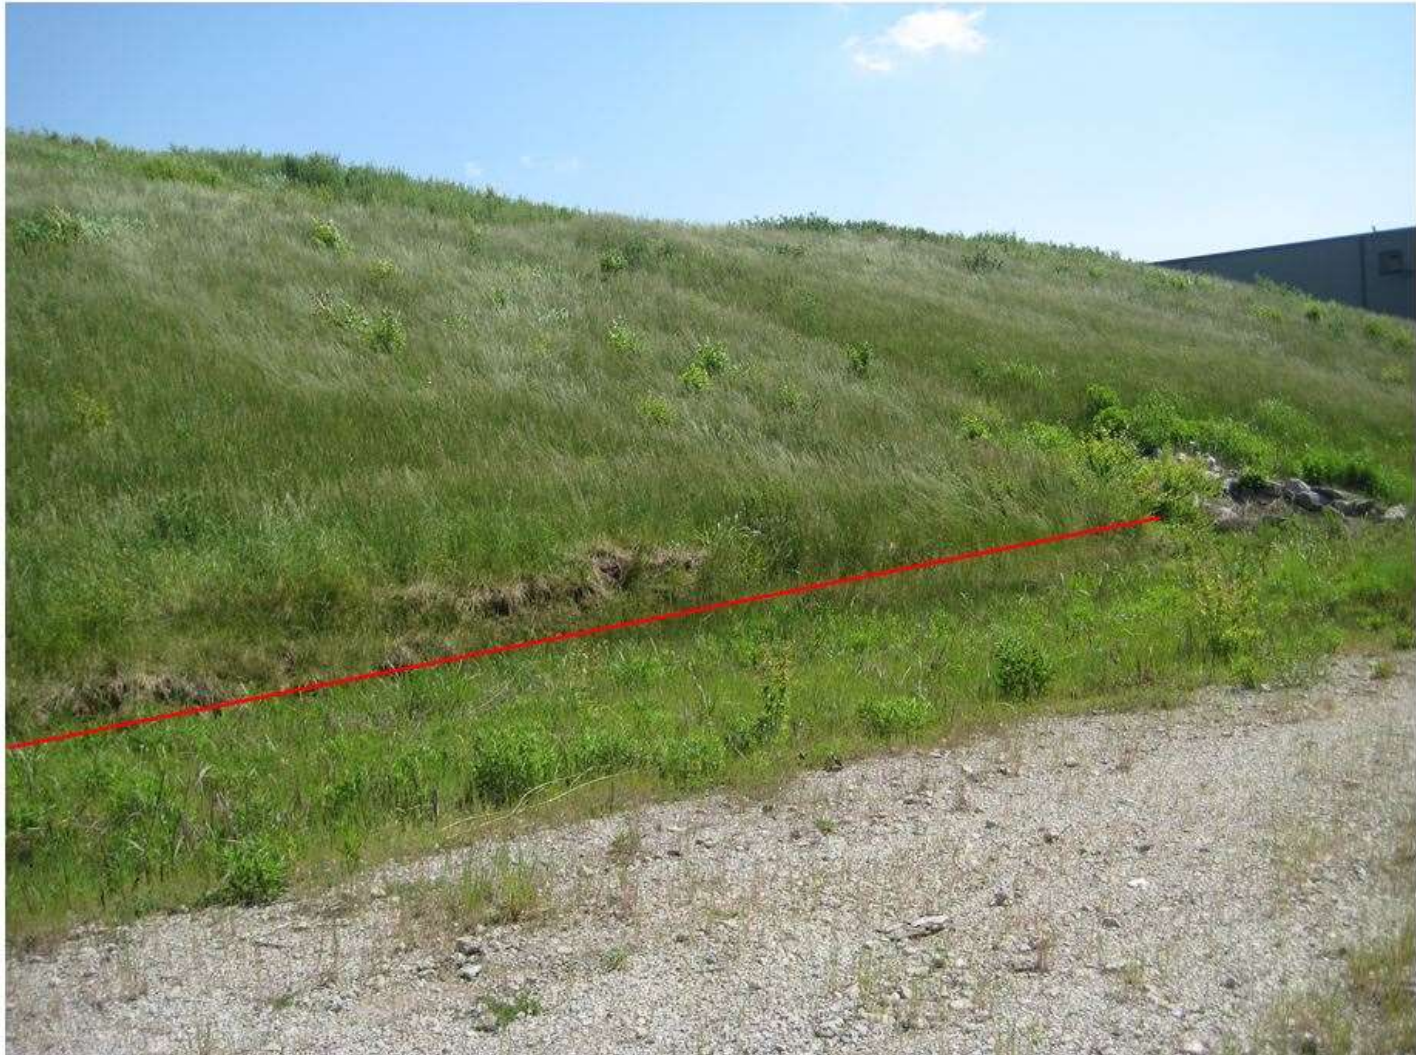
**Photo 7. (South Slope) Bulge at Toe**

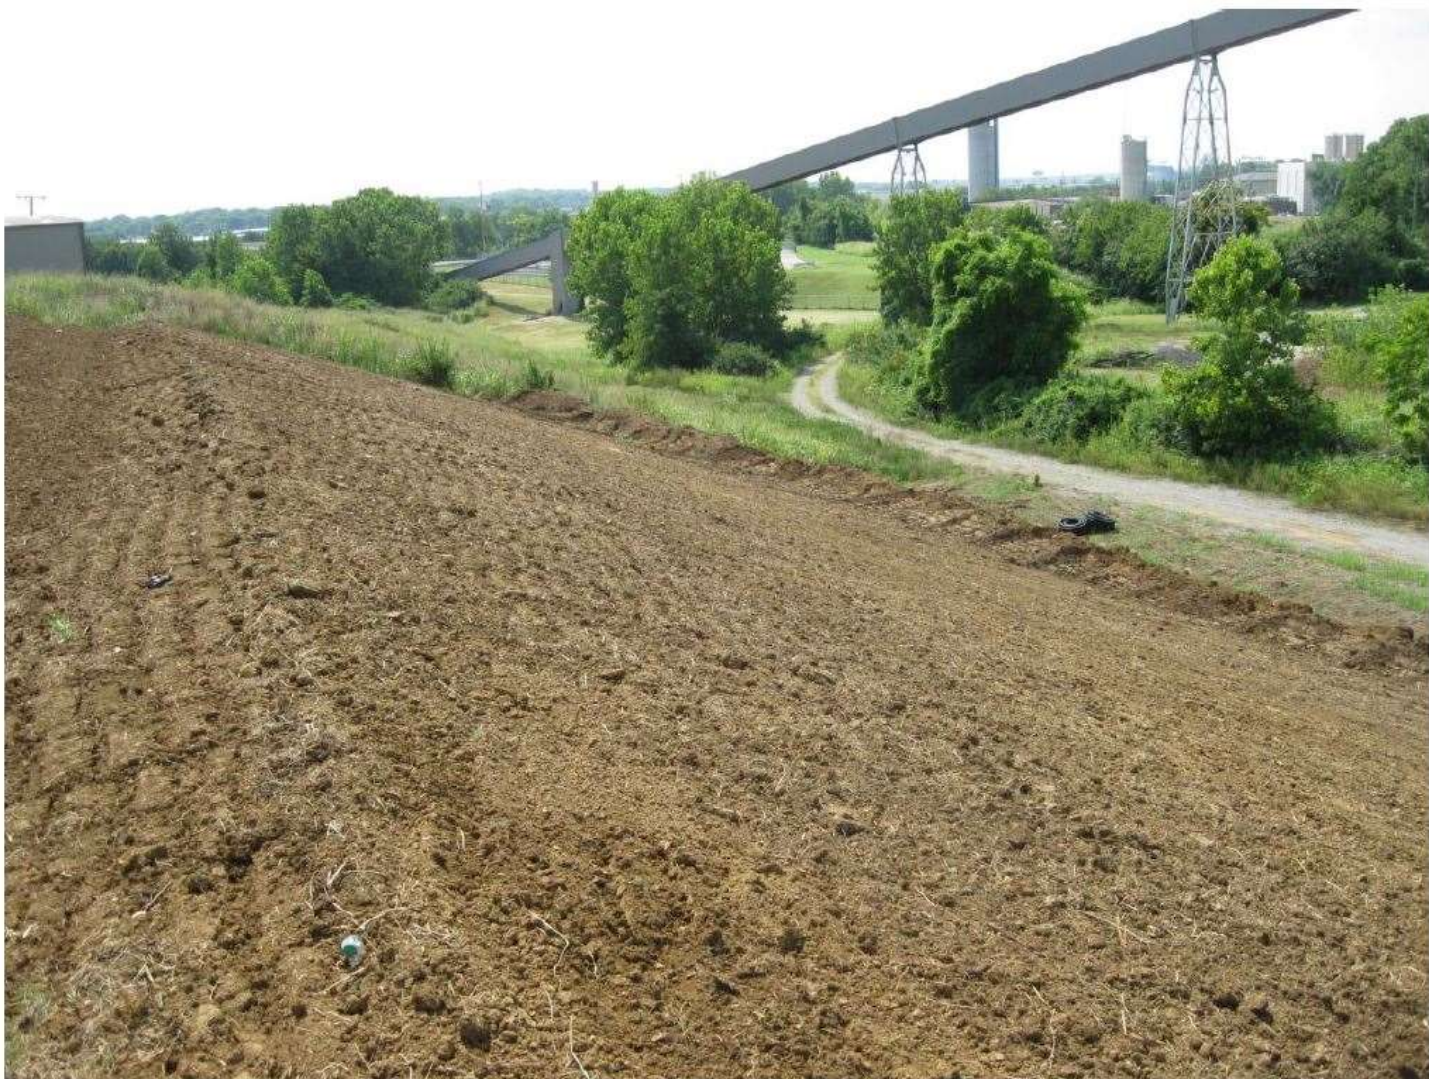
**Subarea-A, bench restoration, looking southeast**

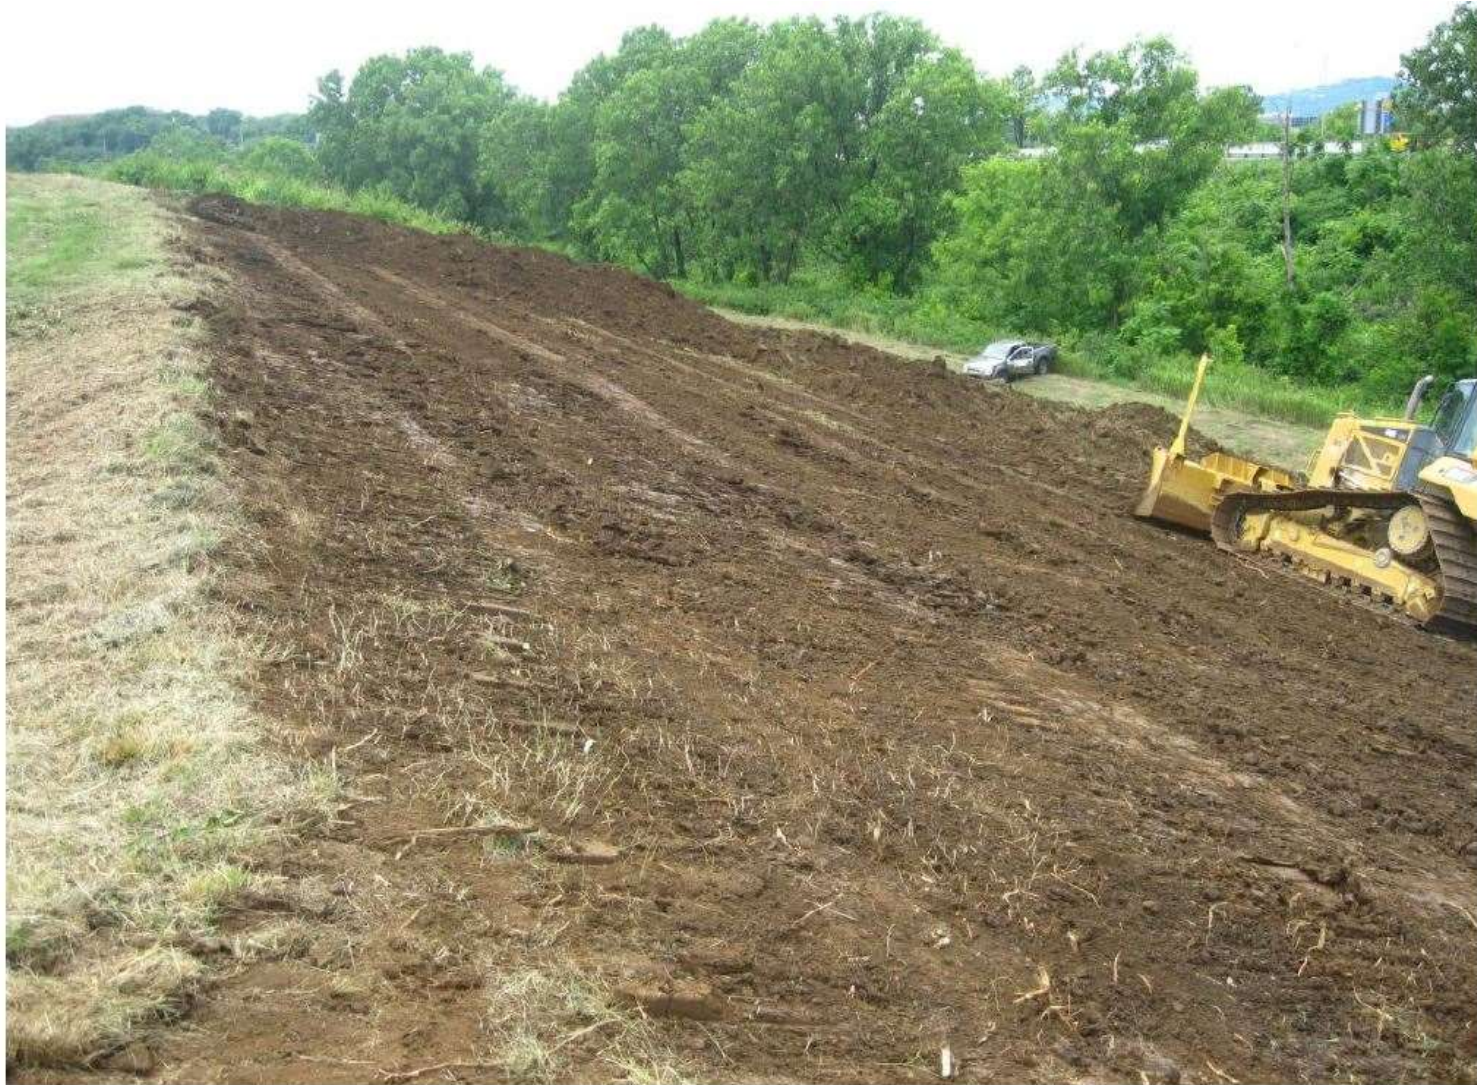
**Removing vegetative layer, Subarea-B**

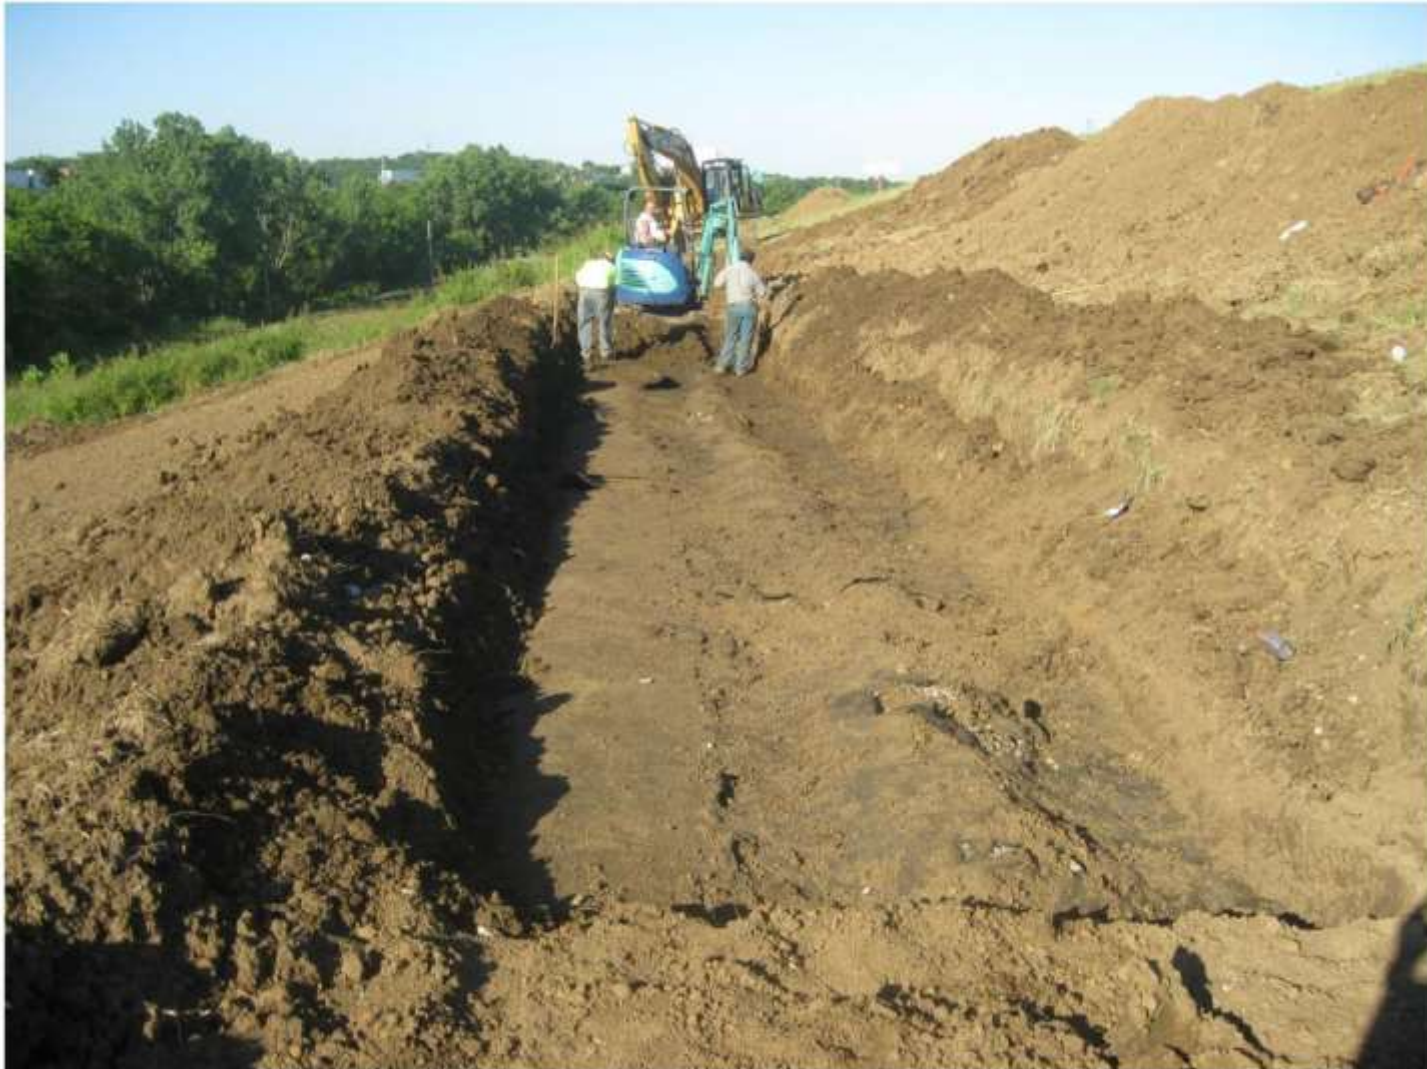
**Exposed Bench Drain, top of slope, Subarea-B**

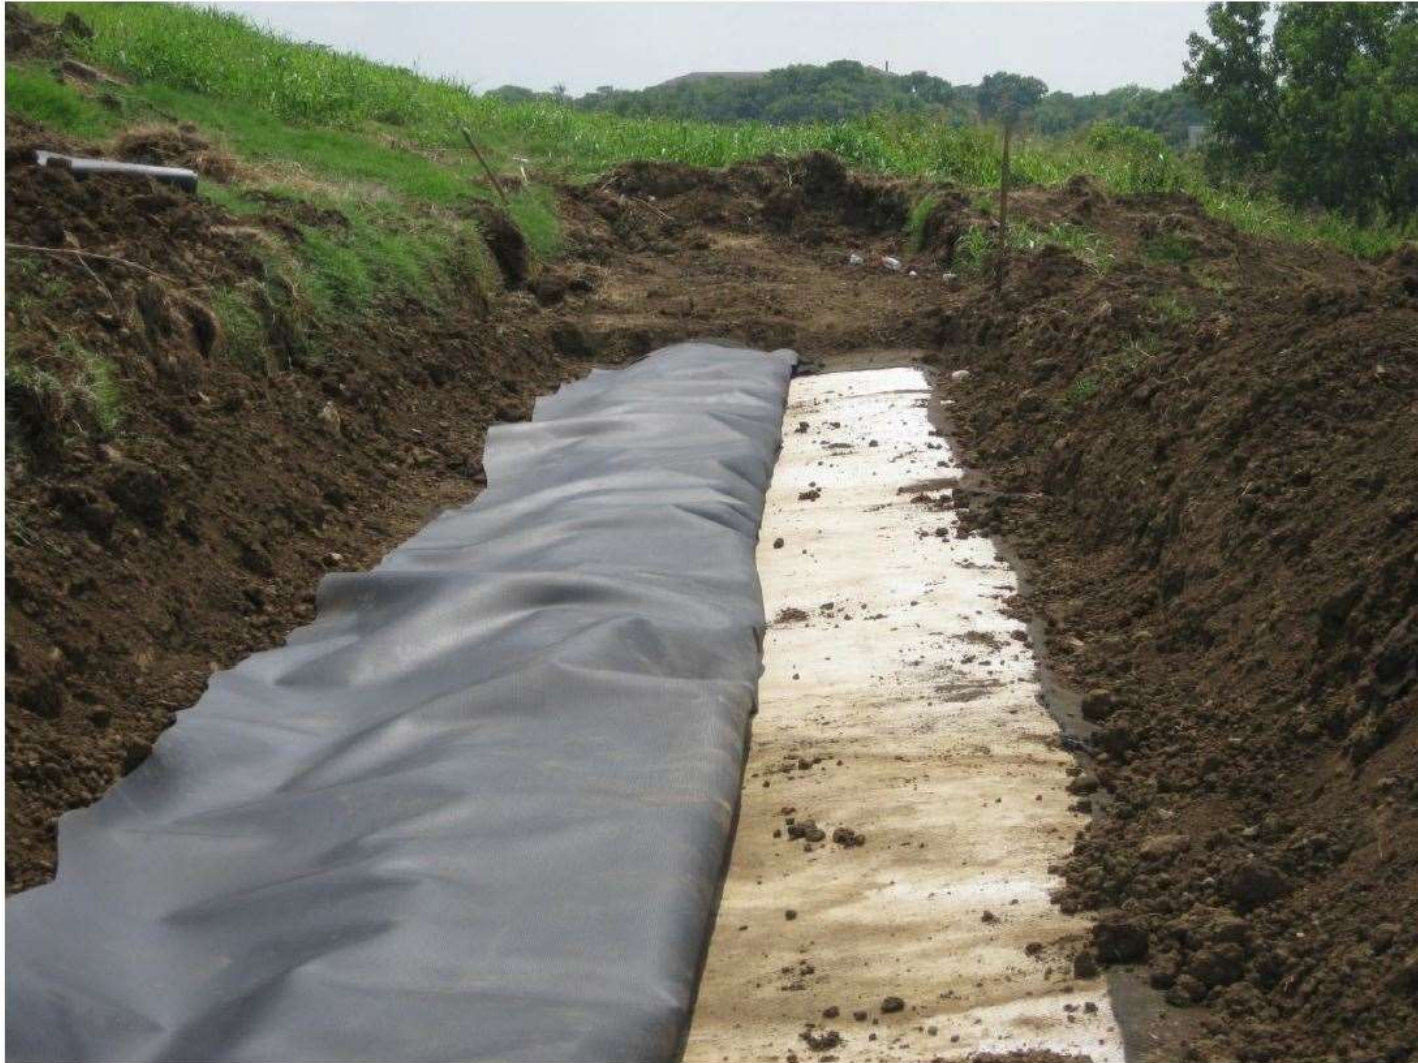
**Subarea-B, completeing bench restoration**

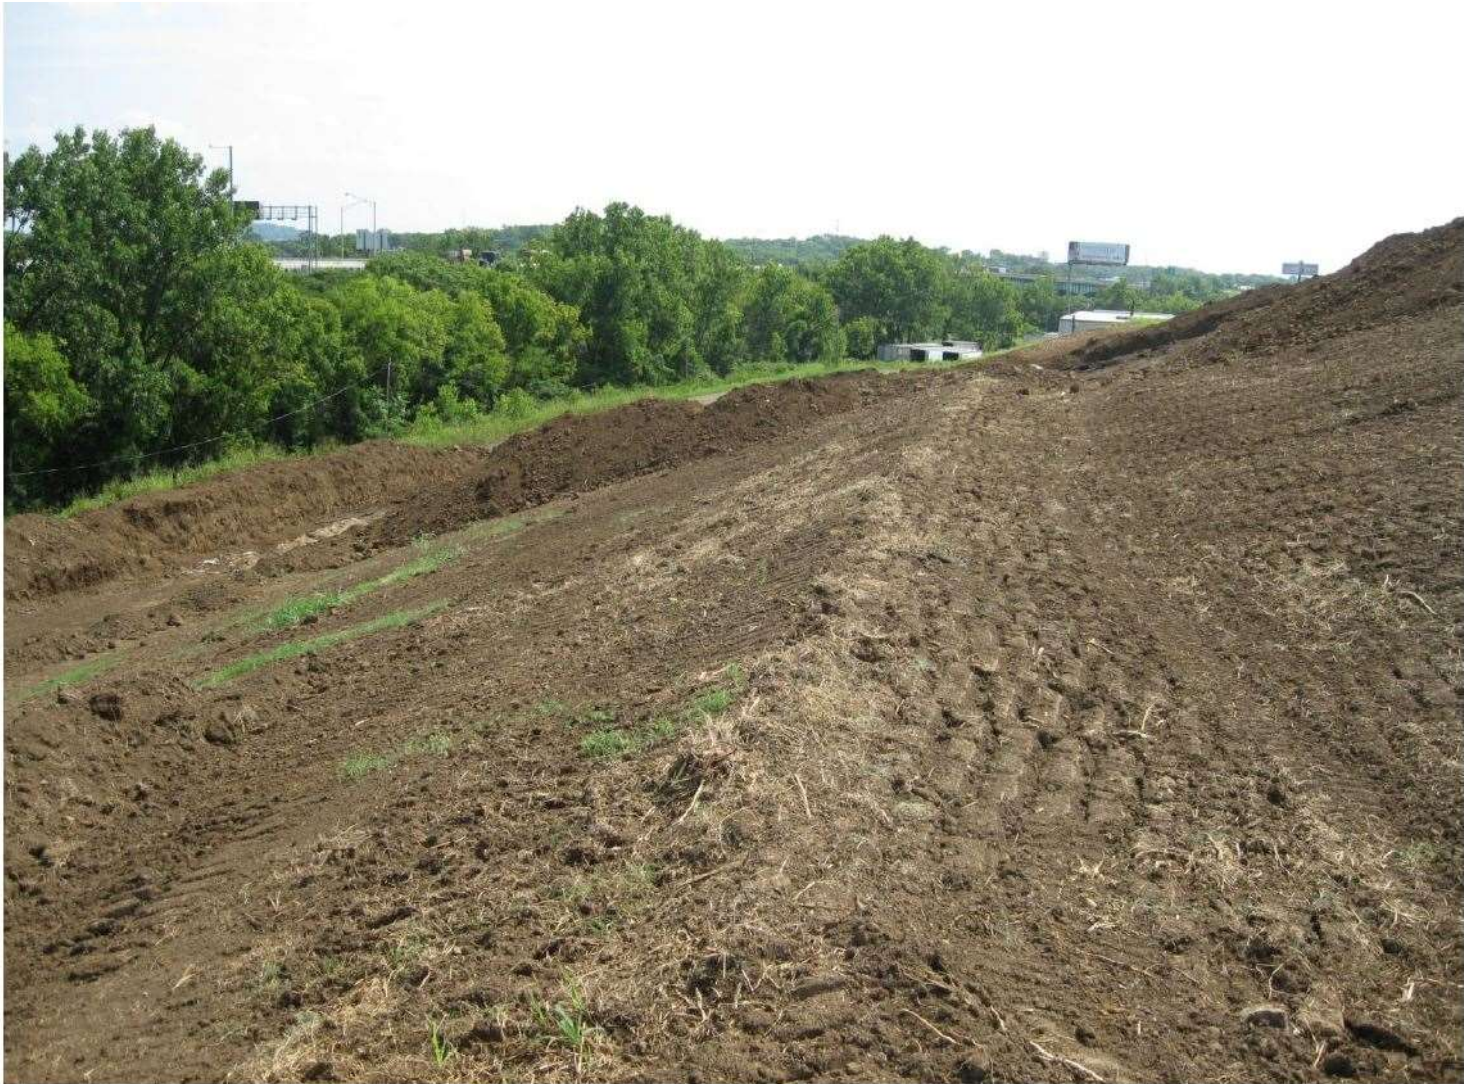
**Subarea-B, completed bench restoration. Backfilled bench, added topsoil**

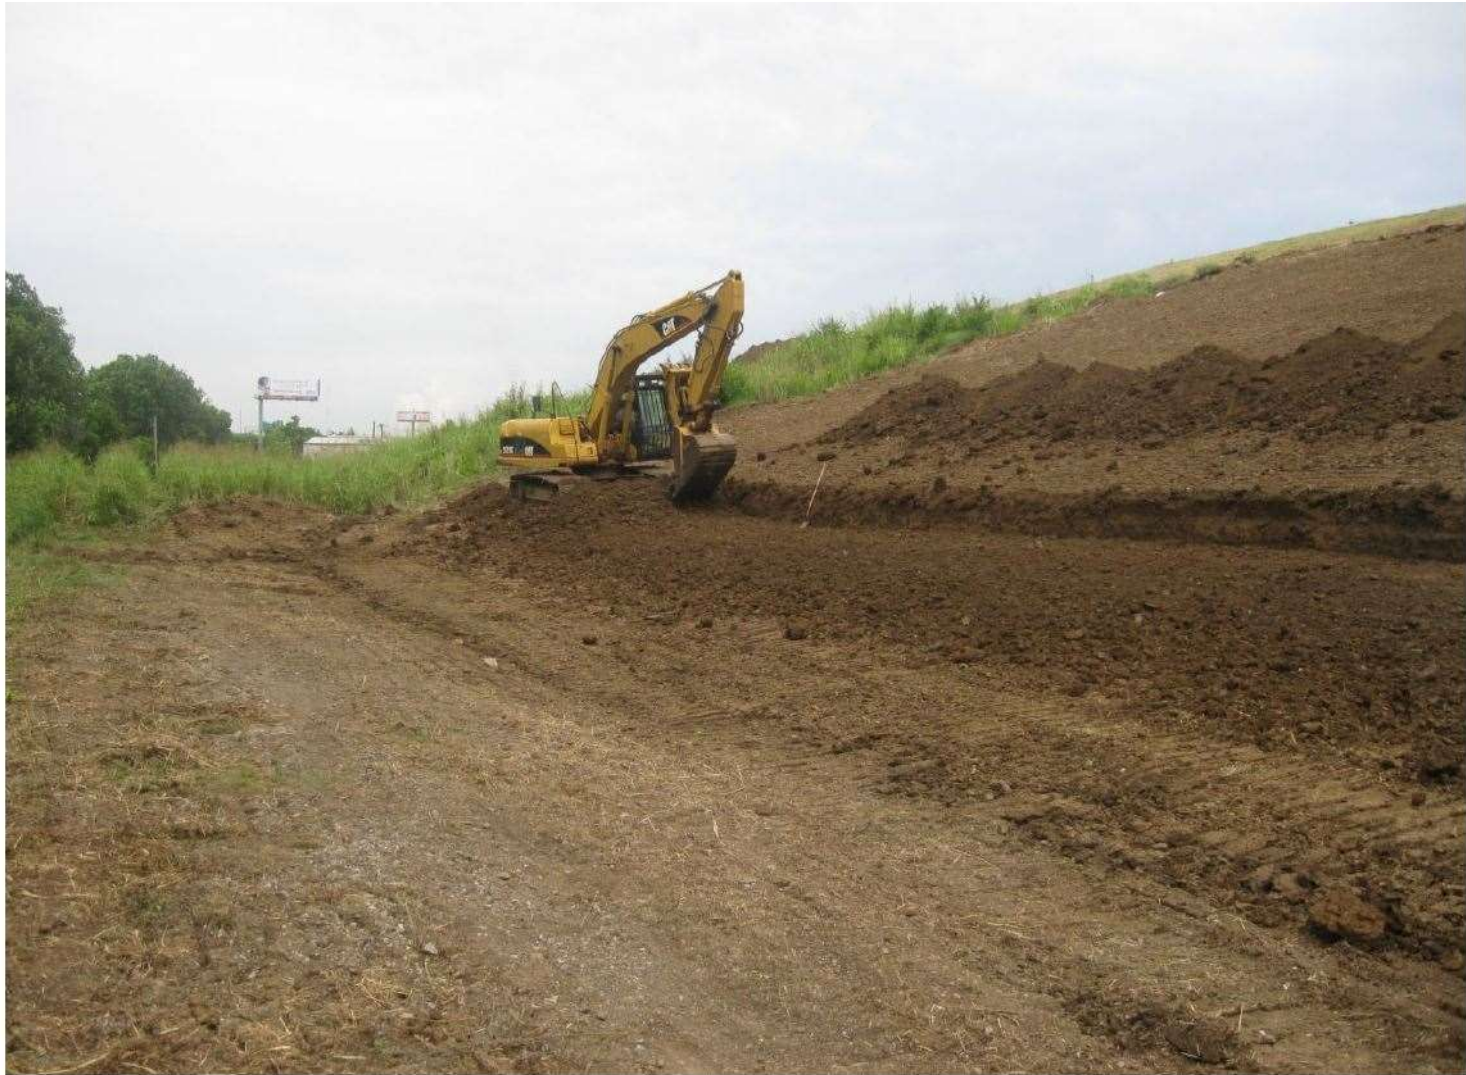
**Cutting in slope for cap drain modification, Subarea-B, looking east**

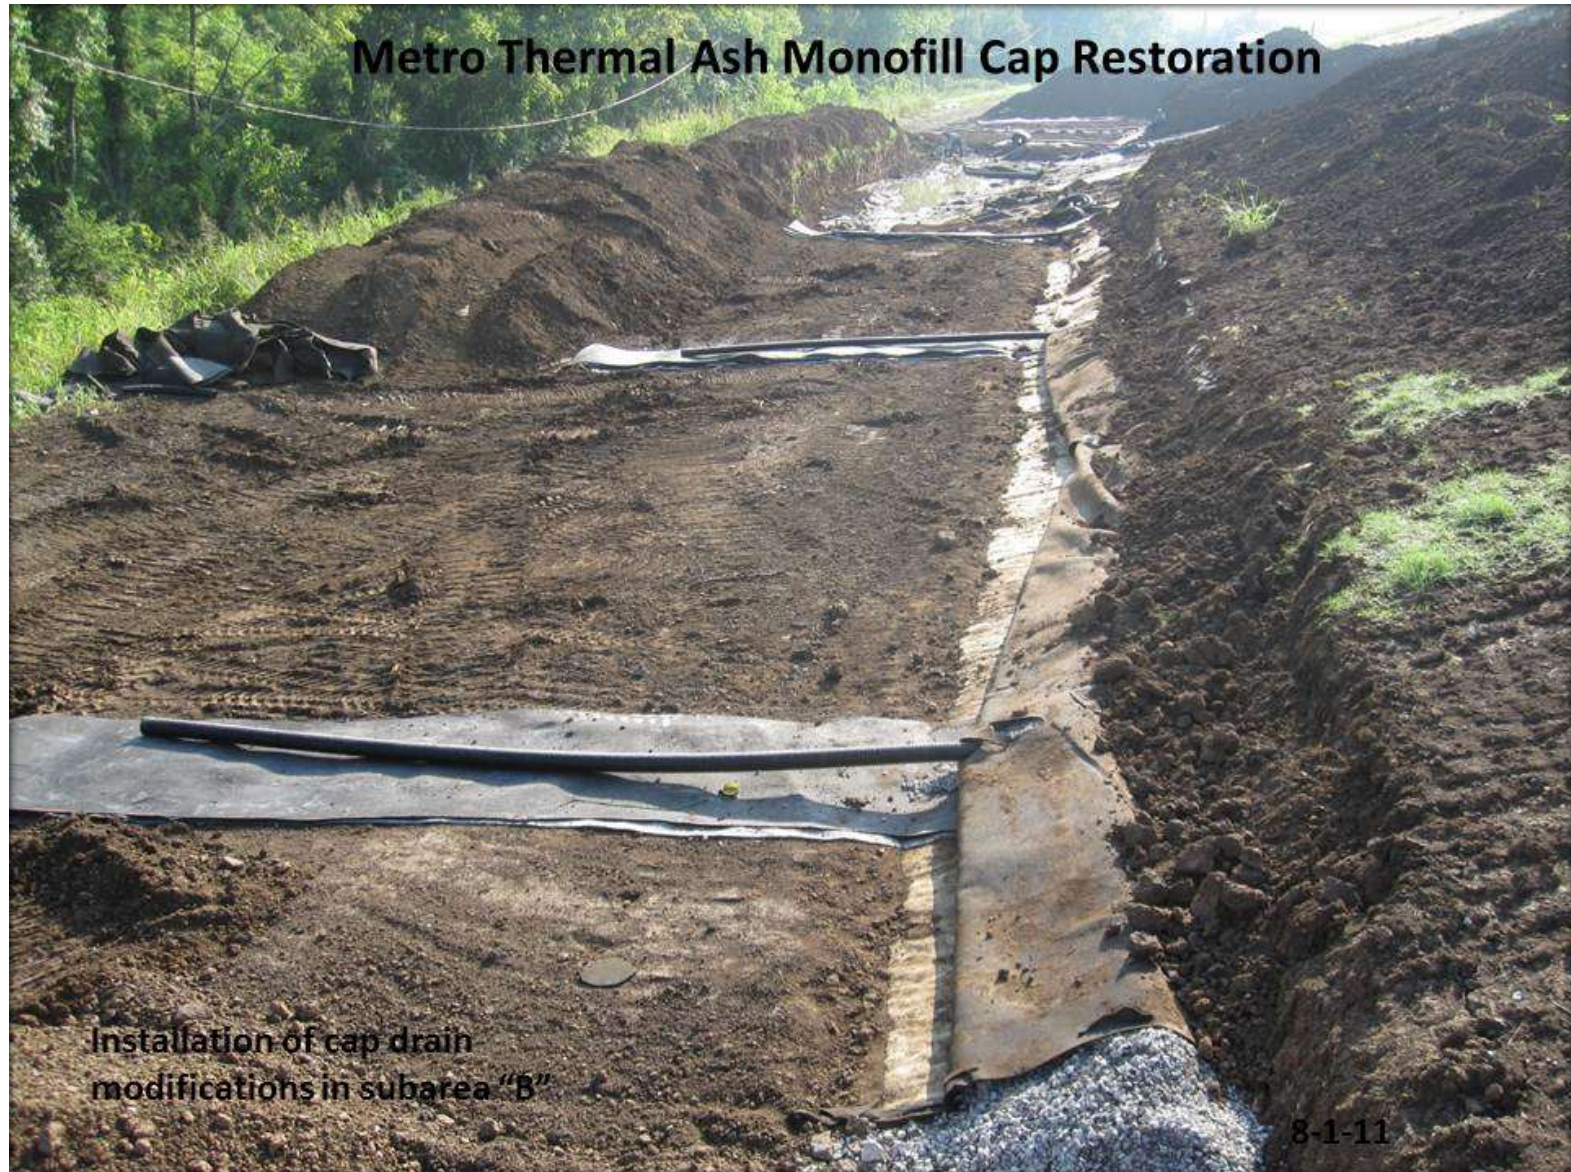
Installation of cap drain  
modifications in subarea "B"

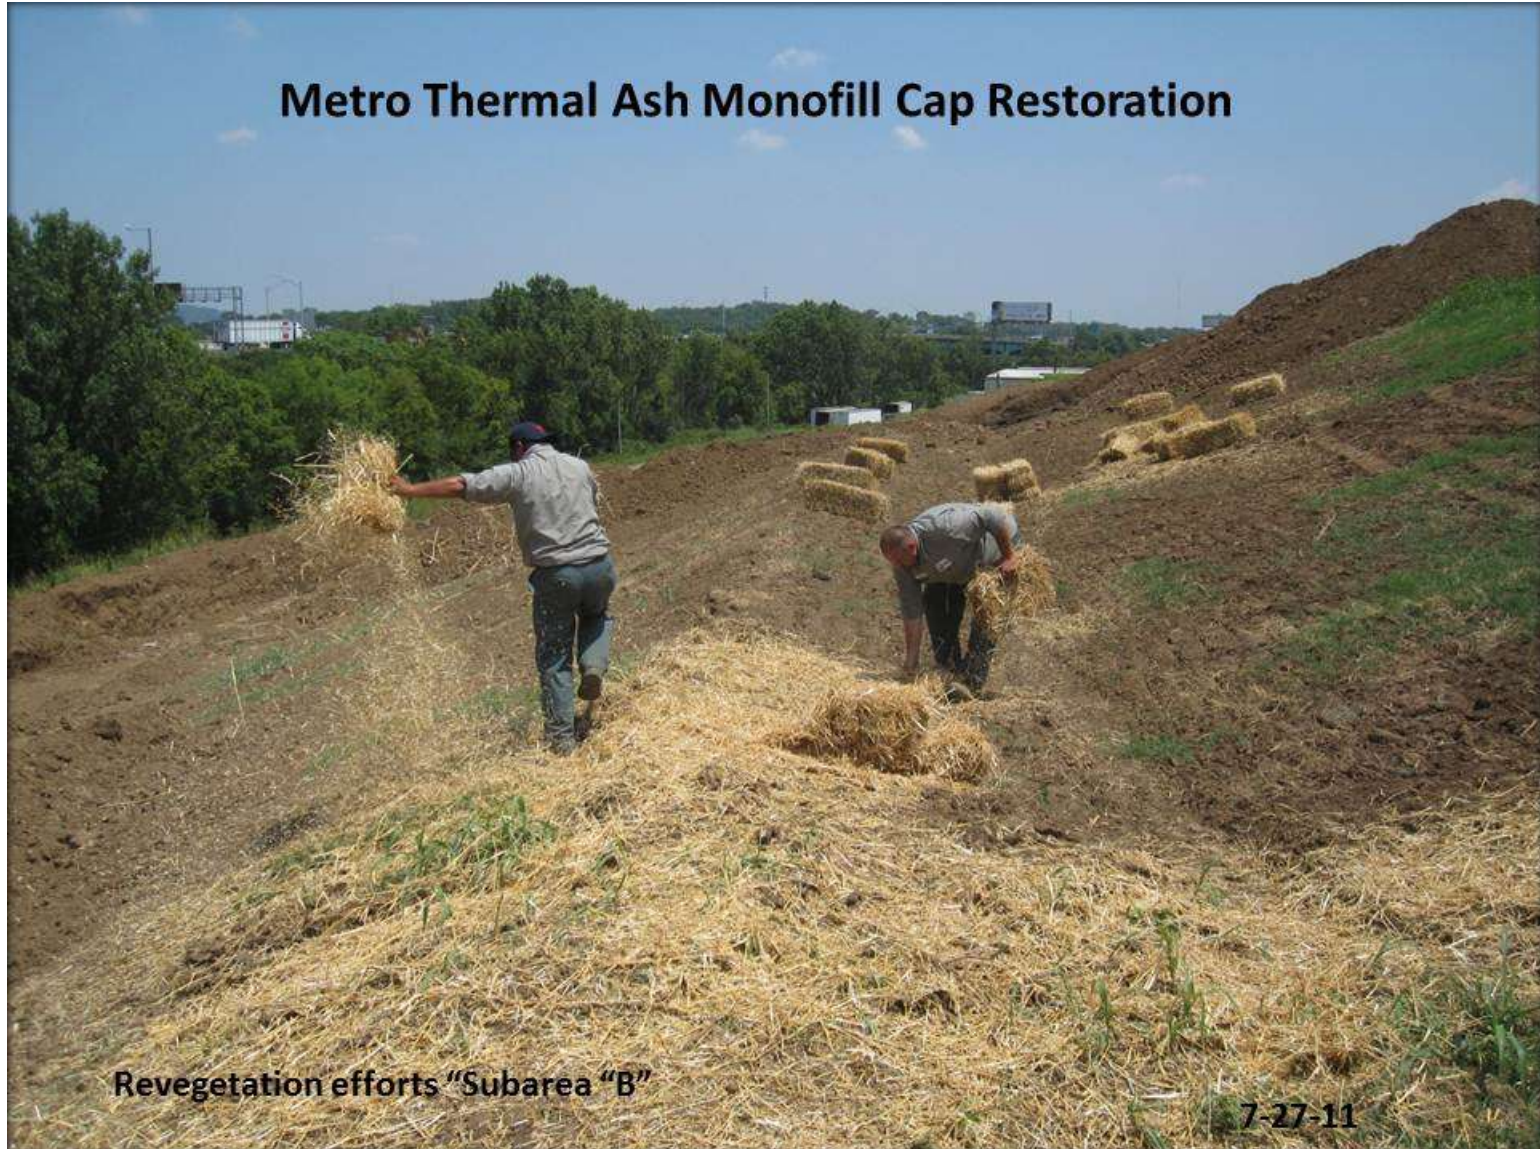
**Revegetation efforts "Subarea B"**

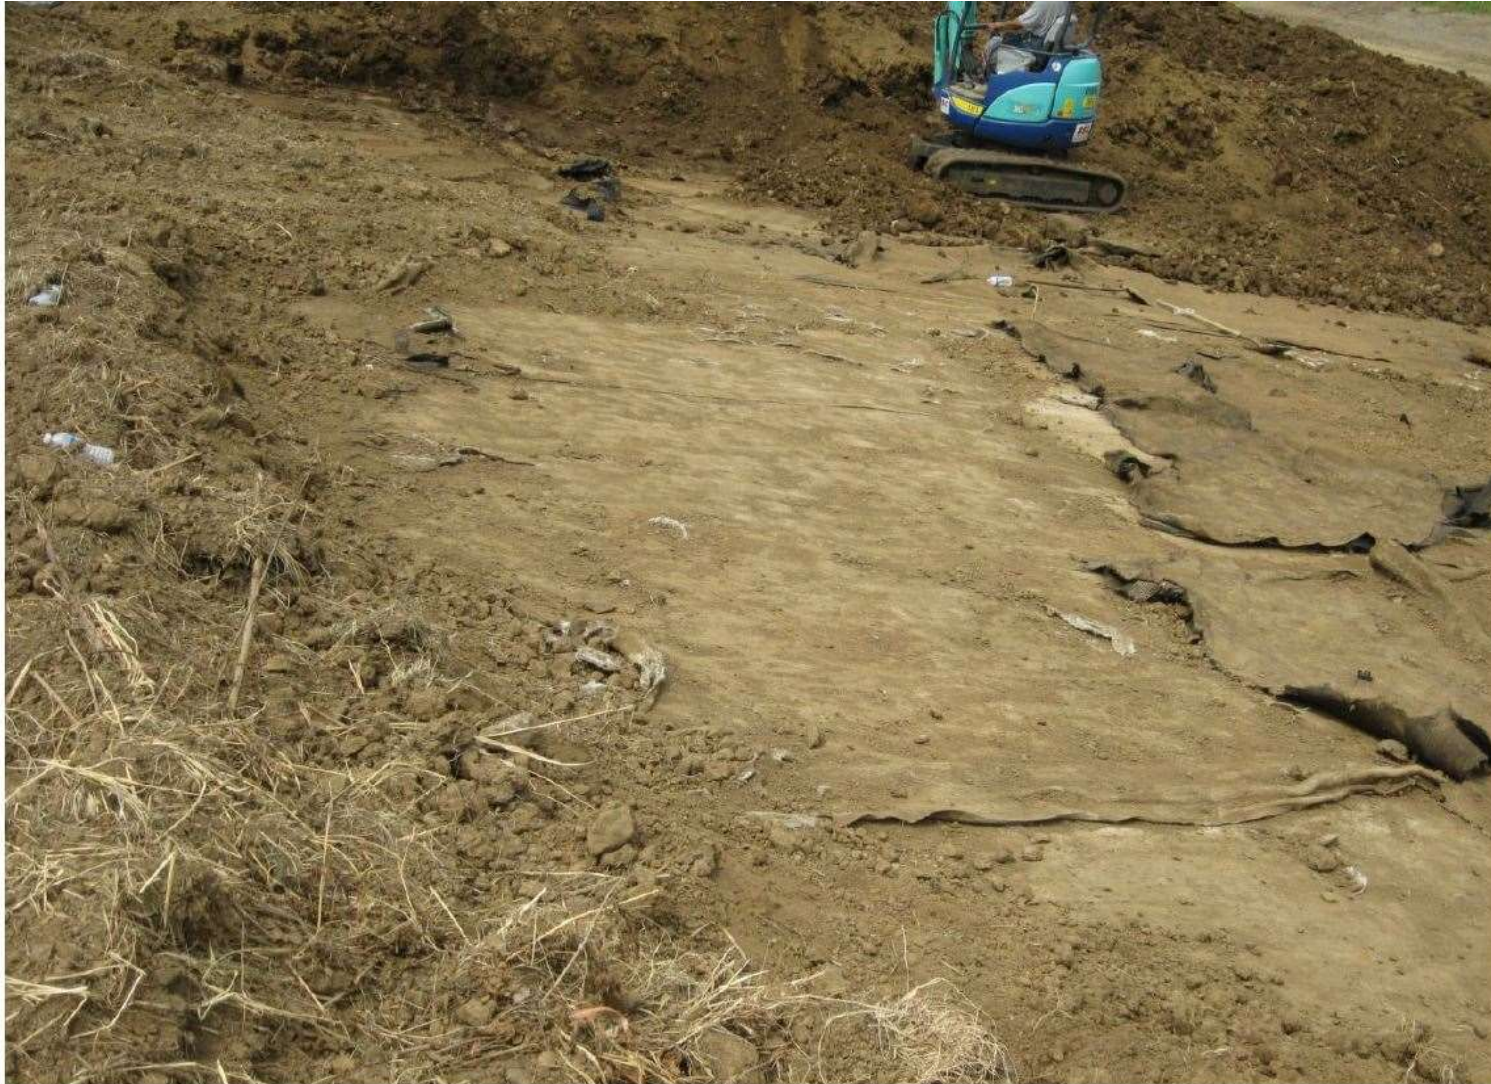
**Subarea-C, Removing cover material to expose liner over entire slope**

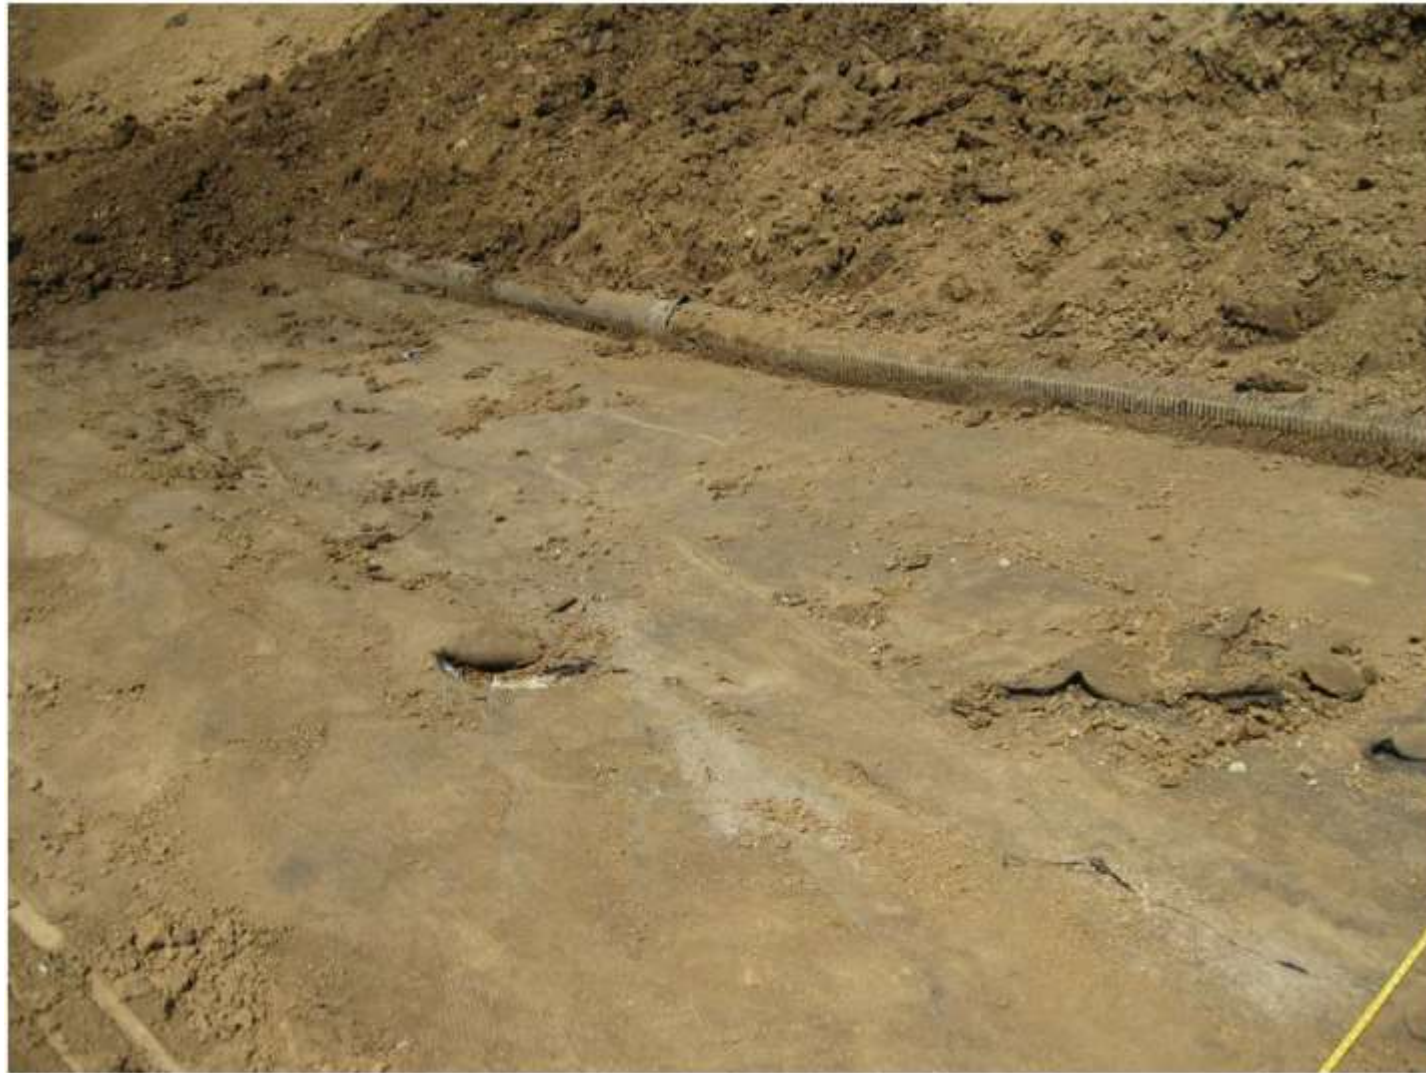
**Subarea-C, underdrain in eastern let-down structure**

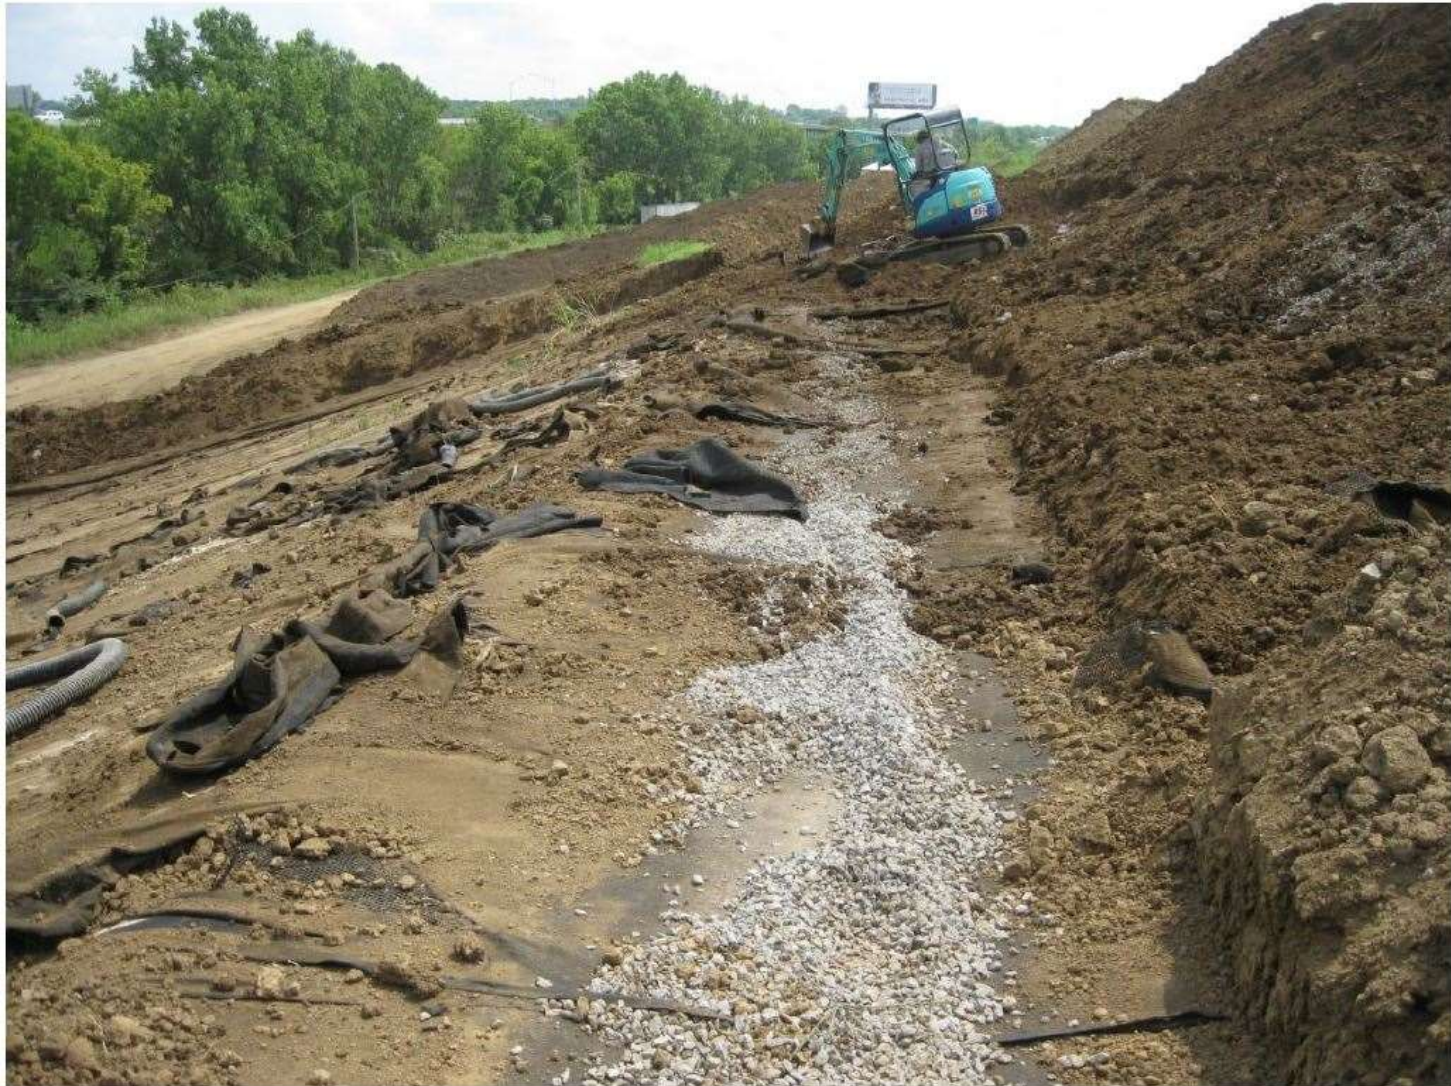
**Subarea-C, Removing cover material to expose liner in bench**
